COTTONWOOD WEST INDUSTRIAL PARK PHASE I ENVIRONMENTAL SITE ASSESSMENT AND PRELIMINARY PHASE II ANALYSIS

COTTONWOOD WEST INDUSTRIAL PARK

PHASE I ENVIRONMENTAL SITE ASSESSMENT AND

ARVADA, COLORADO

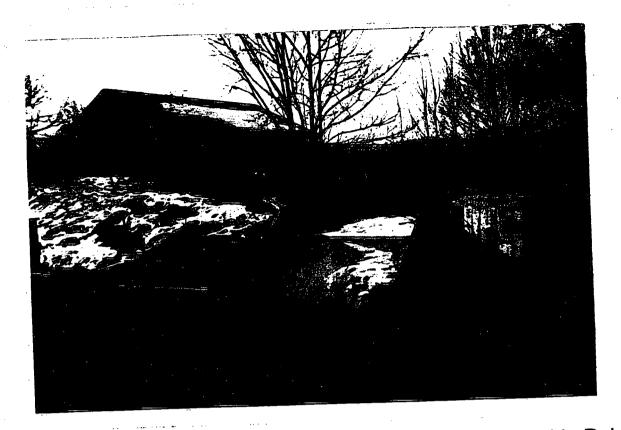
View looking west. Arvada City Water pumphouse along side Ralston Creek spillway into Croke canal. Note frozen creek water on west side of canal.

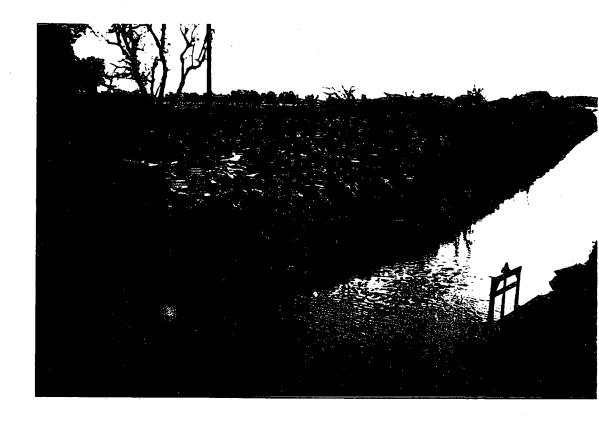
View southeasterly along the north western bank of the LTMR site; Croke Canal front and right, gate to Ralston Creek on left. Very high canal banks here.

In the landfill, there is very likely a perched water table. This could be caused by "clay lifts" within the landfill. The underlying permanent water table must certainly be affected by the level of the Croke Canal seasonally. The banks of the canal were not measured for this report, but the Croke Canal is unusually deep (estimated 30- to 35-foot banks) on the subject site. The water to feed Croke Canal is supplied from Clear Creek.

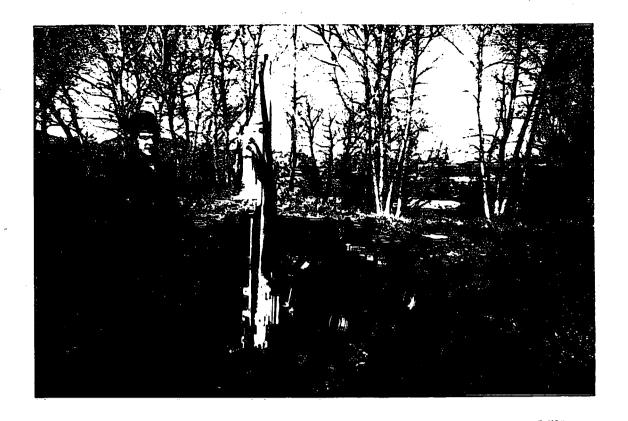
Hole #1 with Mobile Drill Rig. Equipment operator for scale.

Part of this environmental site assessment effort was to acquire groundwater and surface water samples from the property. The 1982 Chen drilling activity revealed explosive levels of methane emanating from the subsurface. Methane is a common component of landfills and originates from the decay of buried organic material in the refuse. Since it was thus established that methane is present, Ogden utilized a drive tube technique of installing monitoring wells. The drive tube system is very cost effective and somewhat safer to operate in a potentially explosive atmosphere.
